Warranty Extension: 2018-20 Accord A/C Condenser

AFFECTED VEHICLES

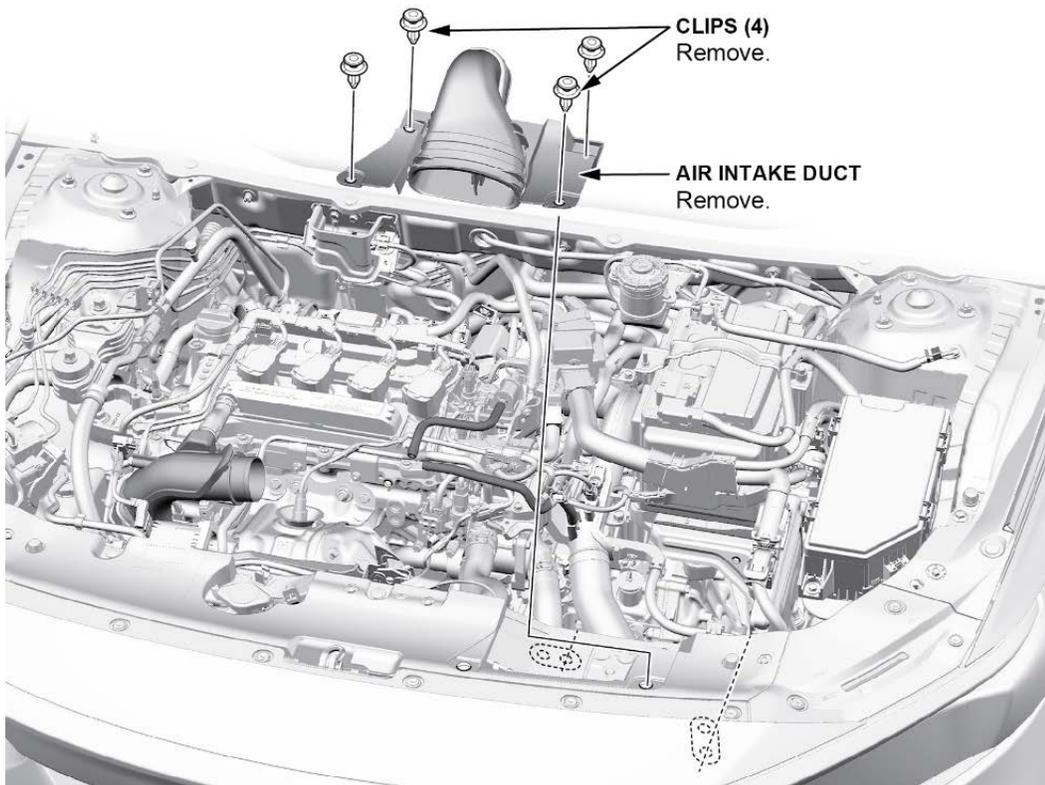
4. Remove the left-front and right-front grille covers.

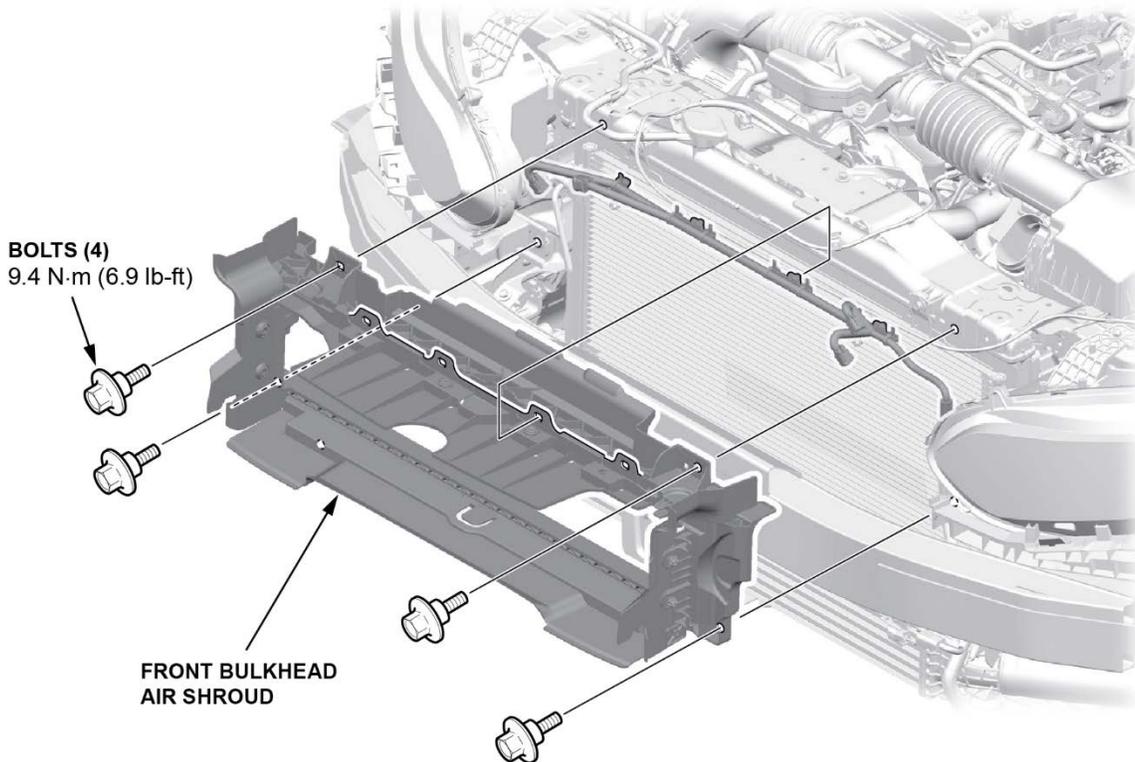
13. Check for leaks in the central condenser area.

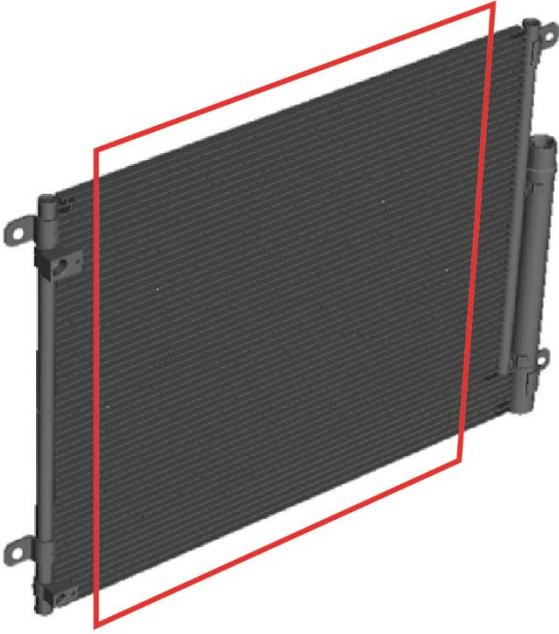
14. Check the joints between the horizontal tubes and the vertical pipes.

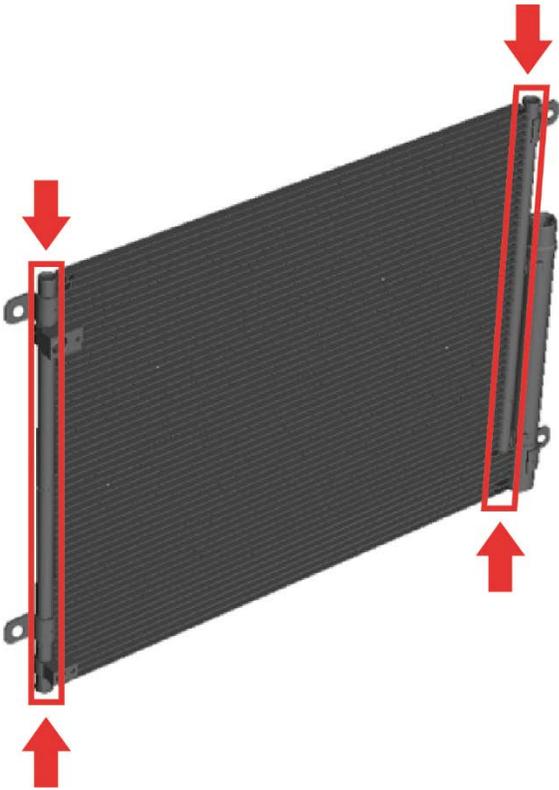
15. Check the inlet and outlet joints and the dryer cap for leaks.

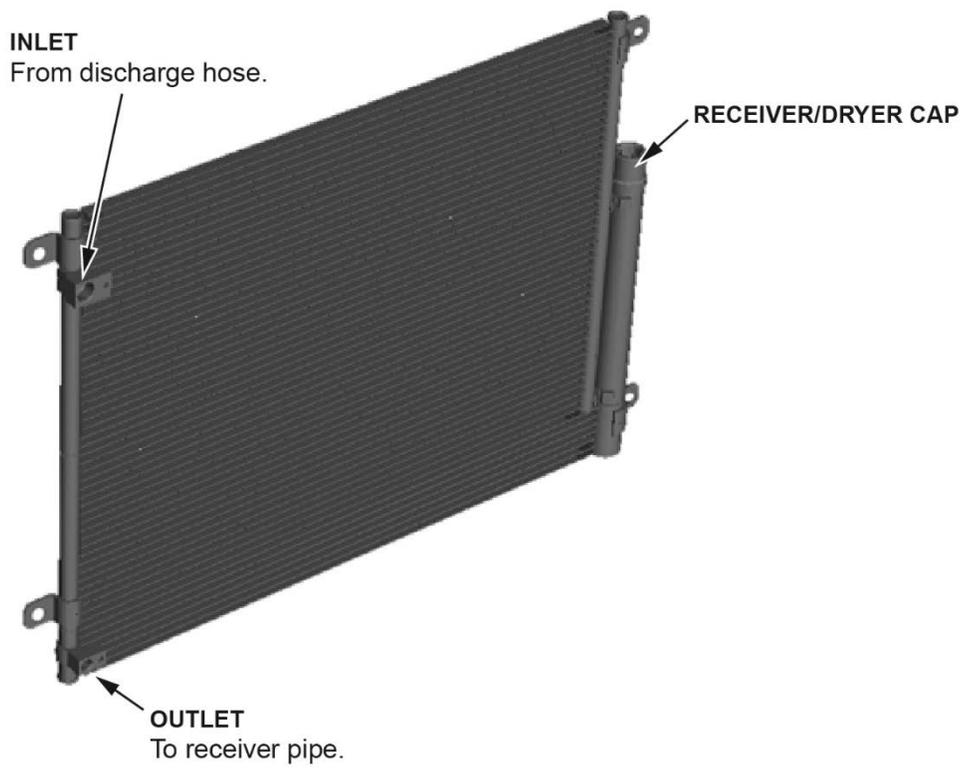
Examples of leaks detected with dye

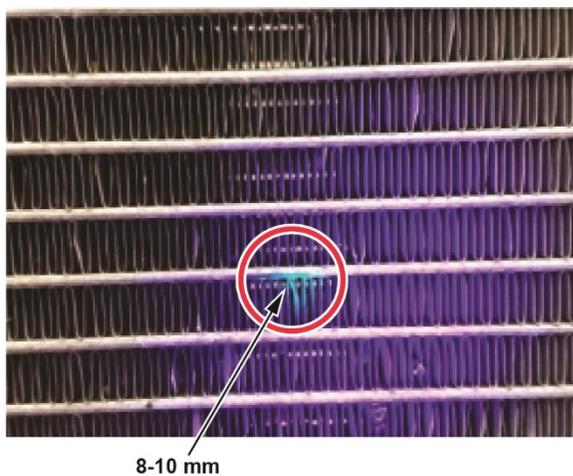
Some leaks are visible with the correct angle of UV light. This leak is deep in the groove between fins.

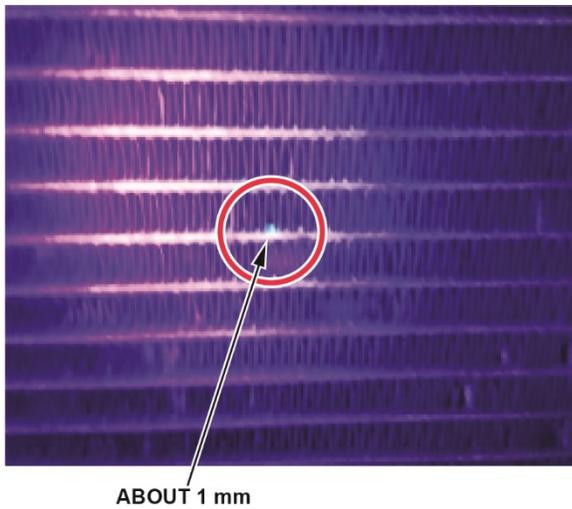
Some leaks may not be visible from certain angles. Aim the UV light from different angles to detect leaks on horizontal tube surfaces.

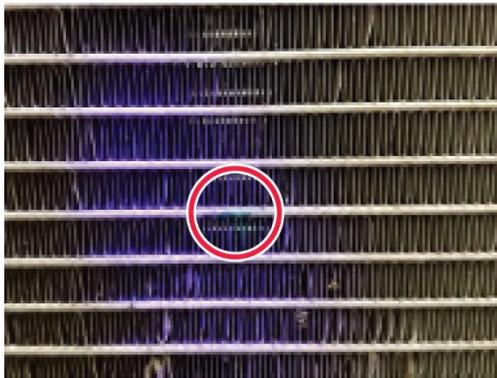
UV LIGHT POINTING UP

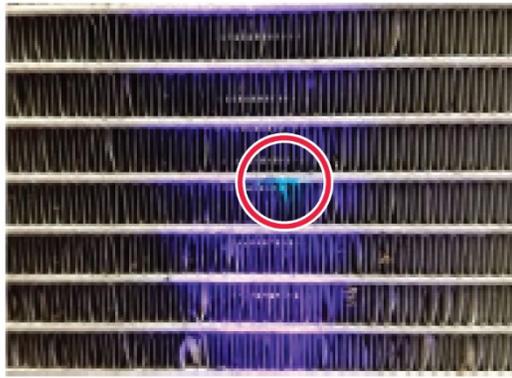
Some condensers may have multiple leaks.

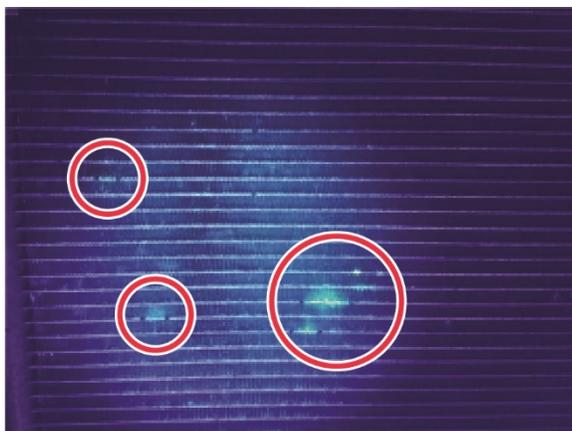
- *If the condenser is leaking, go to the next step.*
- *If the condenser is not leaking, this bulletin does not apply. Continue with normal troubleshooting.*

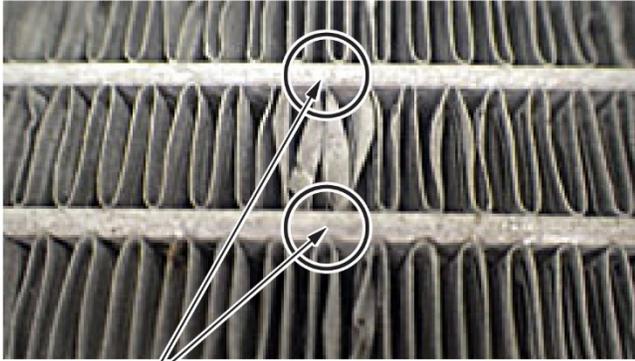
Fin damage without impact damage to the tube face.

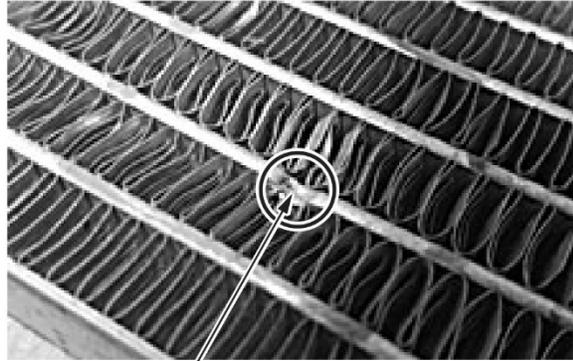
Impact damage on the tube face.

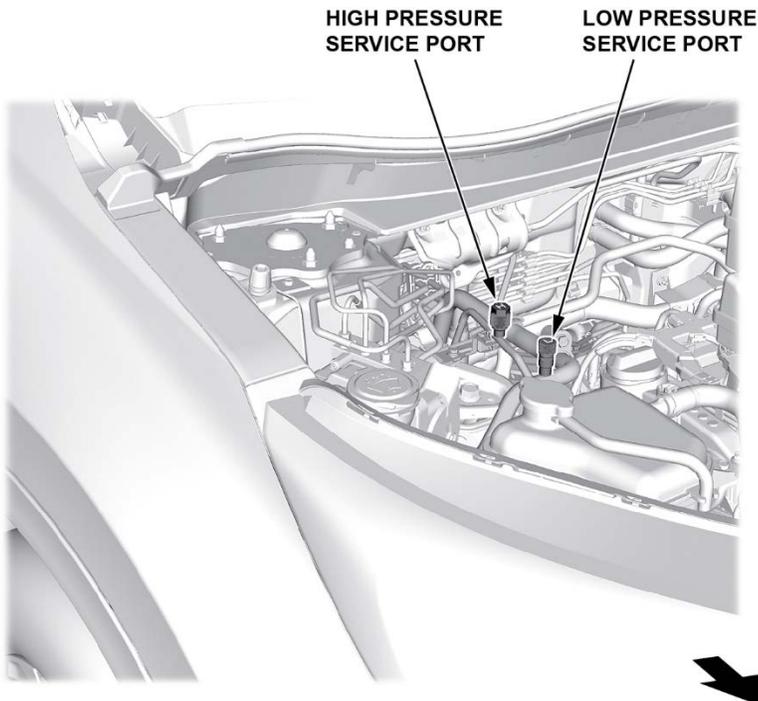
2. Recover the refrigerant from the A/C system.
3. Measure the amount of refrigerant oil removed from the A/C system after the recovery process is completed. Make sure to put the same amount of new refrigerant oil back into the A/C system before charging.
4. Disconnect the intercooler inlet pipe on the passenger side of the intercooler.

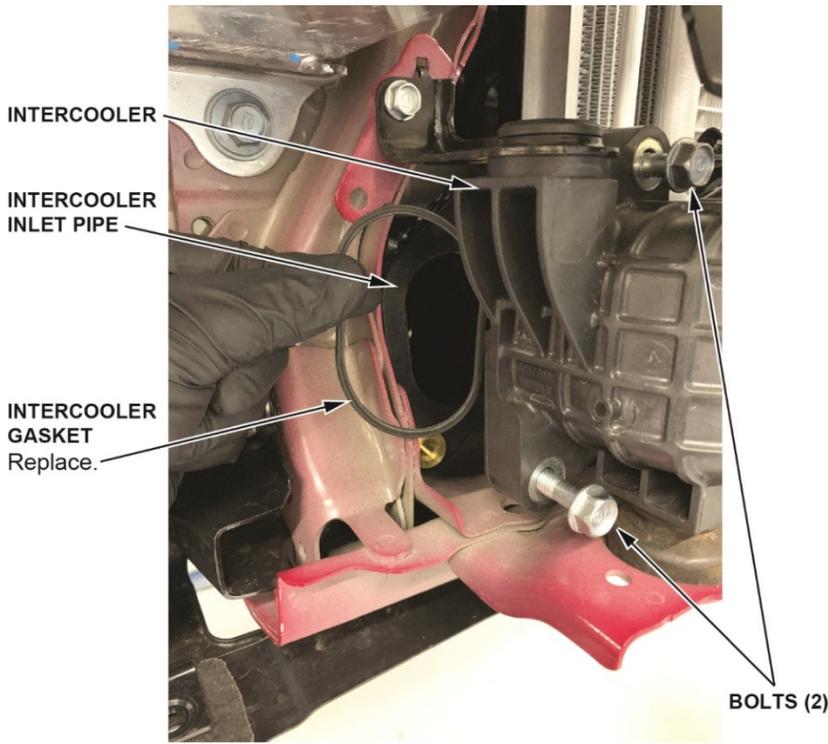
5. Push the intercooler inlet pipe away from the intercooler until the condenser discharge hose is visible.
